NASA TM X-53400

**QUALIFICATION OF THE GEMINI SE-7 ENGINE AS THE
SATURN S-IVB STAGE ULLAGE CONTROL THRUSTER**

By DONALD E. PRYOR

The Gemini SE-7 Engine was qualification tested for use as the ullage motor for the Saturn S-IVB stage. The engine was subjected to hot firing tests and vibration/shock tests. All program objectives were met and the engine was deemed qualified for use in the S-IVB stage Auxiliary Propulsion System.

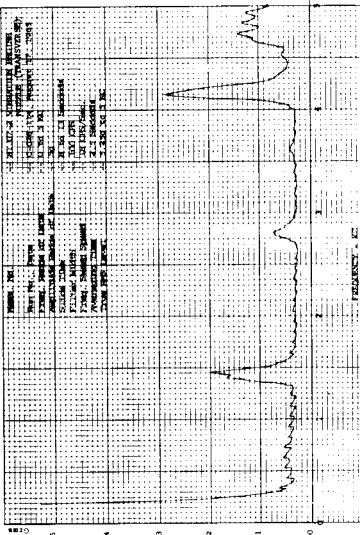
FIG 19 VIBRATION AMPLITUDE VERSUS FREQUENCY AT EXIT MOUNTING FLANGE - TCA 4

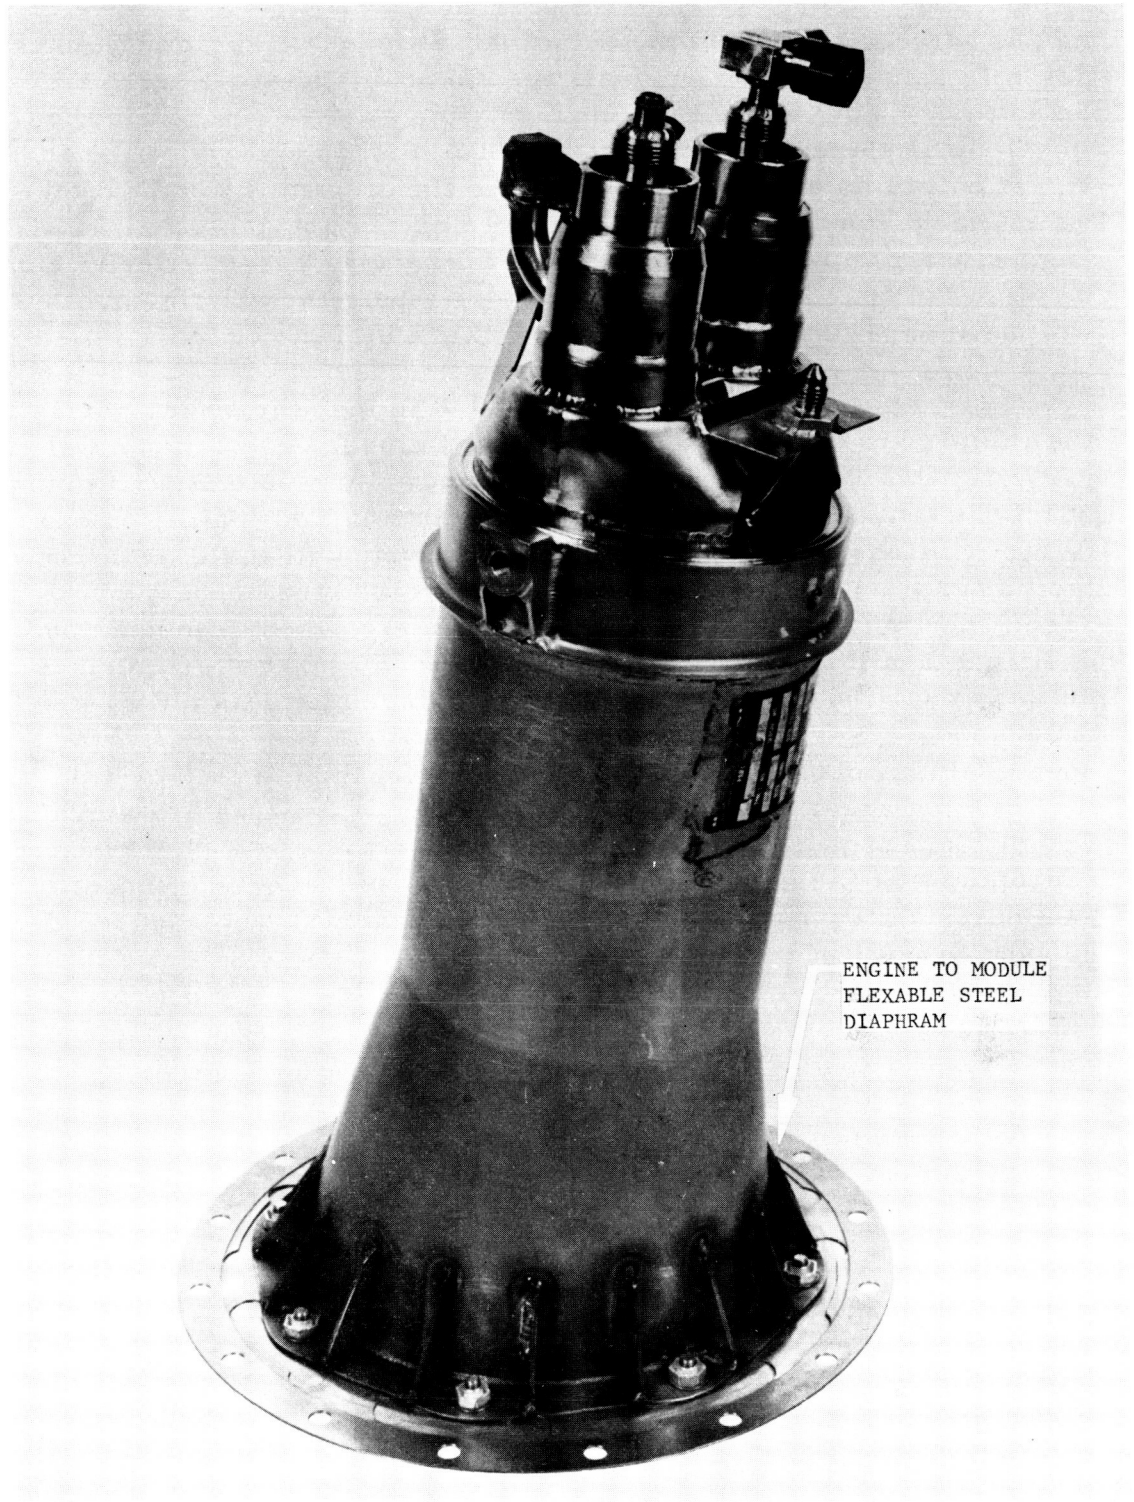
FIG 24 TCA 1 WITH REINFORCED FLANGE
FOR VIBRATION IN THE RADIAL AXIS

modes without subjecting the actual vibration qualification chamber to possible damage. In view of the results of the previous test, care was taken to correctly install the engine. Sine sweep vibration in the longitudinal plane was completed without mishap (Test 9). Random vibration in this plane (Test 10) caused the aft flange to fail in the same manner and area as had occurred on the previous engine. The engine was removed, and triangular reinforcing gussets were welded between the chamber shell and flange to repair the existing break as well as insure further flange failures were eliminated (FIG 24).

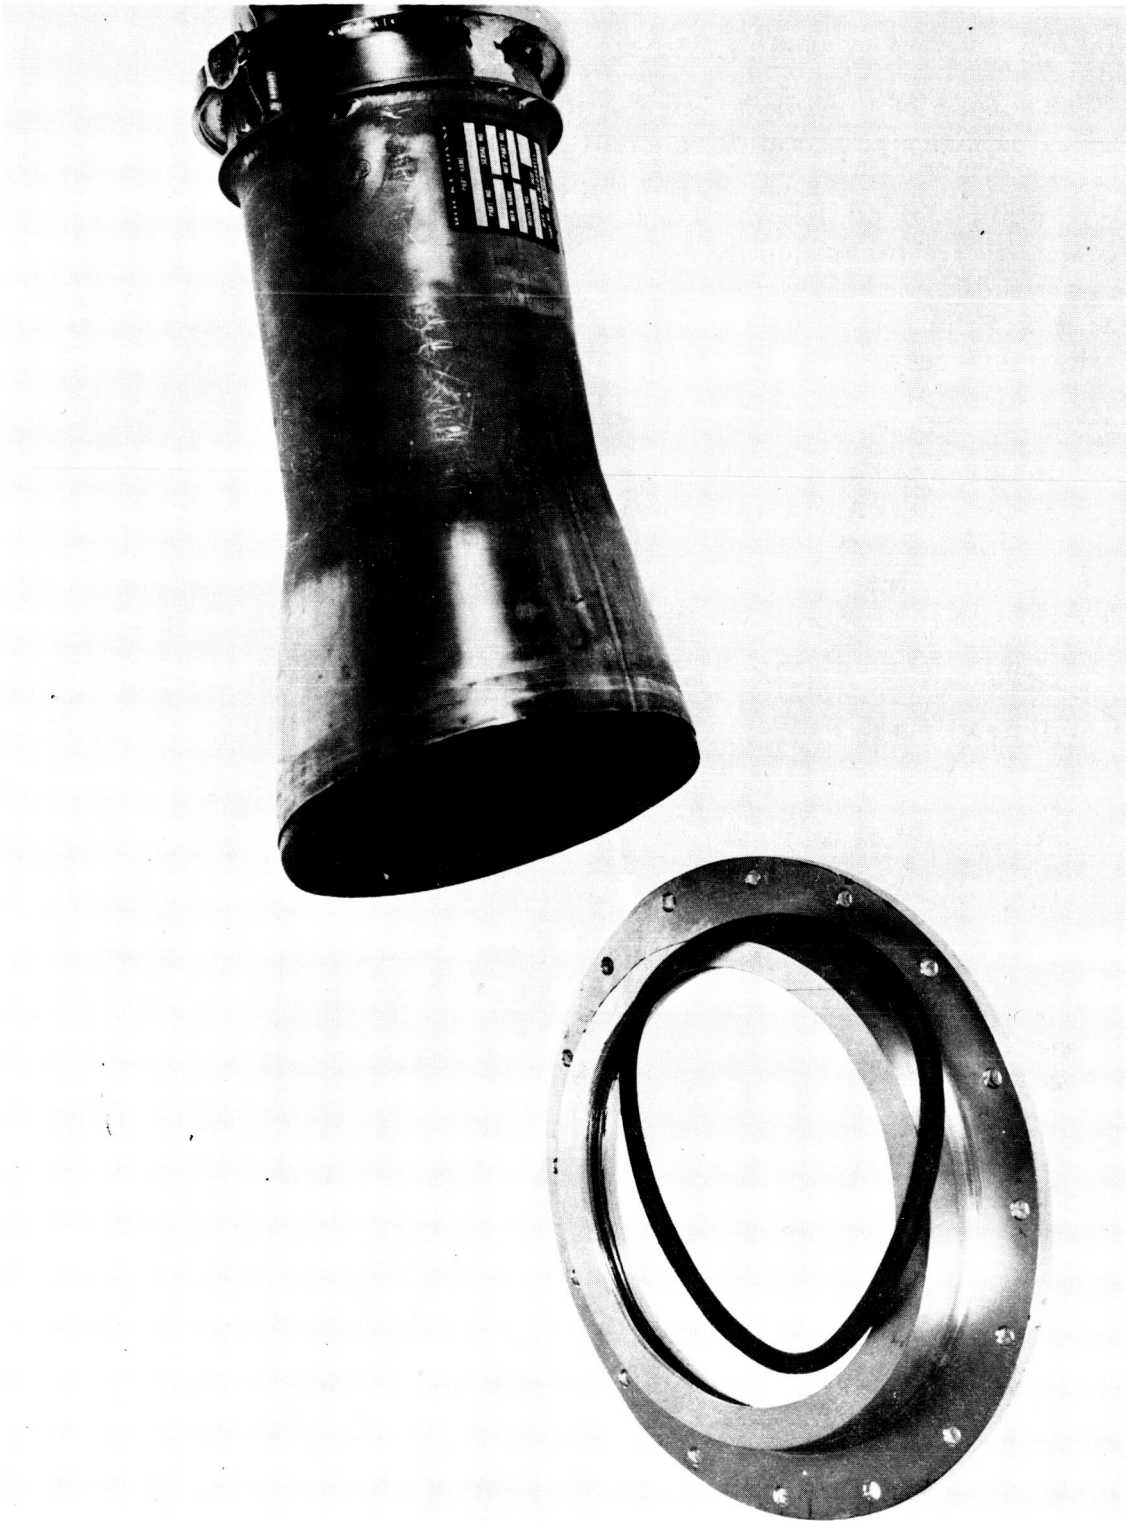
FIG 26 O-RING NOZZLE SUPPORT ASSEMBLY
WITH MODIFIED ENGINE FOR SAME

During the time that the final qualification engine was being modified by Rocketdyne, the O-ring nozzle support described above was designed, fabricated and tested on TCA 2, the engine with the Rocketdyne reinforcements that had just completed the test series. Since the flange C-ring had already been removed to benefit inspection, it was an easy task to manually remove the remaining flange material. The Rocketdyne trunnion reinforcement was not disturbed because it appeared to be acceptable. With TCA 2 modified as described, all three planes of the vibration test series were conducted without incident (Tests 22 through 27) and post test examination did not reveal any test hardware or engine irregularities.
